# Manhole Inspection Summary

# Manhole # S55E\_\_043MH

Insp Date: **5/18/09 3:12 PM**

**Location** Address: **3518 E LOMBARD ST**

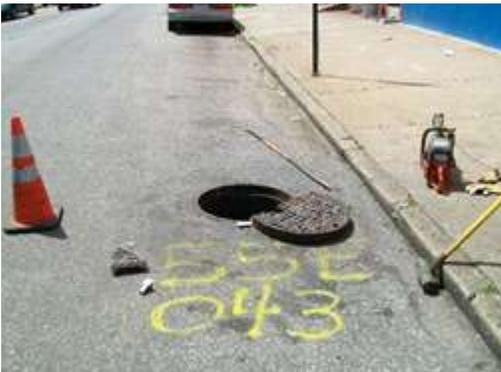
MISC.

CUT OFF COVER TO GAIN ACCESS;  
PAVEMENT MARKED

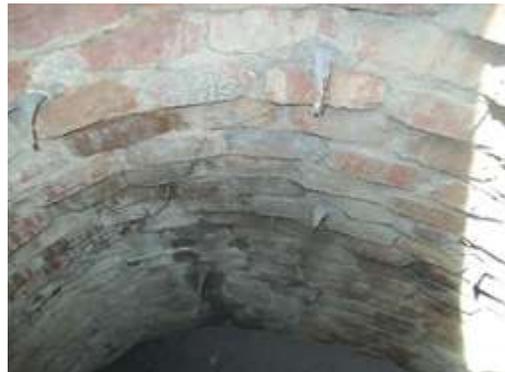
Defect 2

Count: **0** Missing: **4**  **Corroded**

CORRODED MISSING STEPS

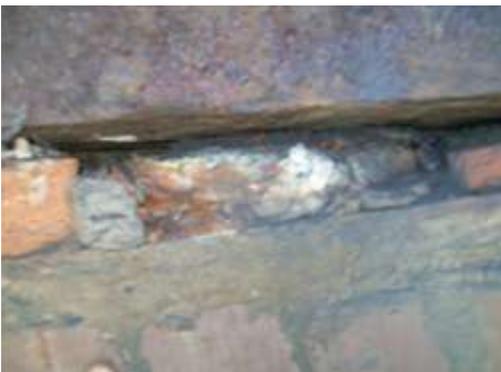
Defect 1

Condition:  Sound  Cracked  Root Intrusion  Loose Brick  **Deteriorated**

DETERIORATED CHIMNEY BRICKS

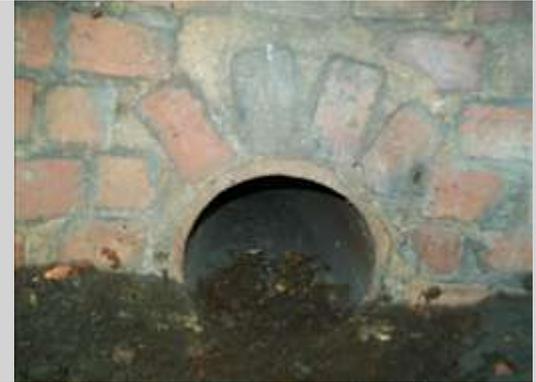
12 O'Clock Outflow

8 in. Circular Gravity Sewer  
Pipe Out @ 12 O'Clock

Infiltration: **None** Pipe Seal Cond: **Sound**
